APPLICATION OF MOBILE LASER SCANNING FOR THE ASSESSMENT OF SLOW-MOVING LANDSLIDE ACTIVITY – A CASE STUDY FROM THE SUDETY MOUNTAINS (SIEDLEĆIN, SW POLAND)

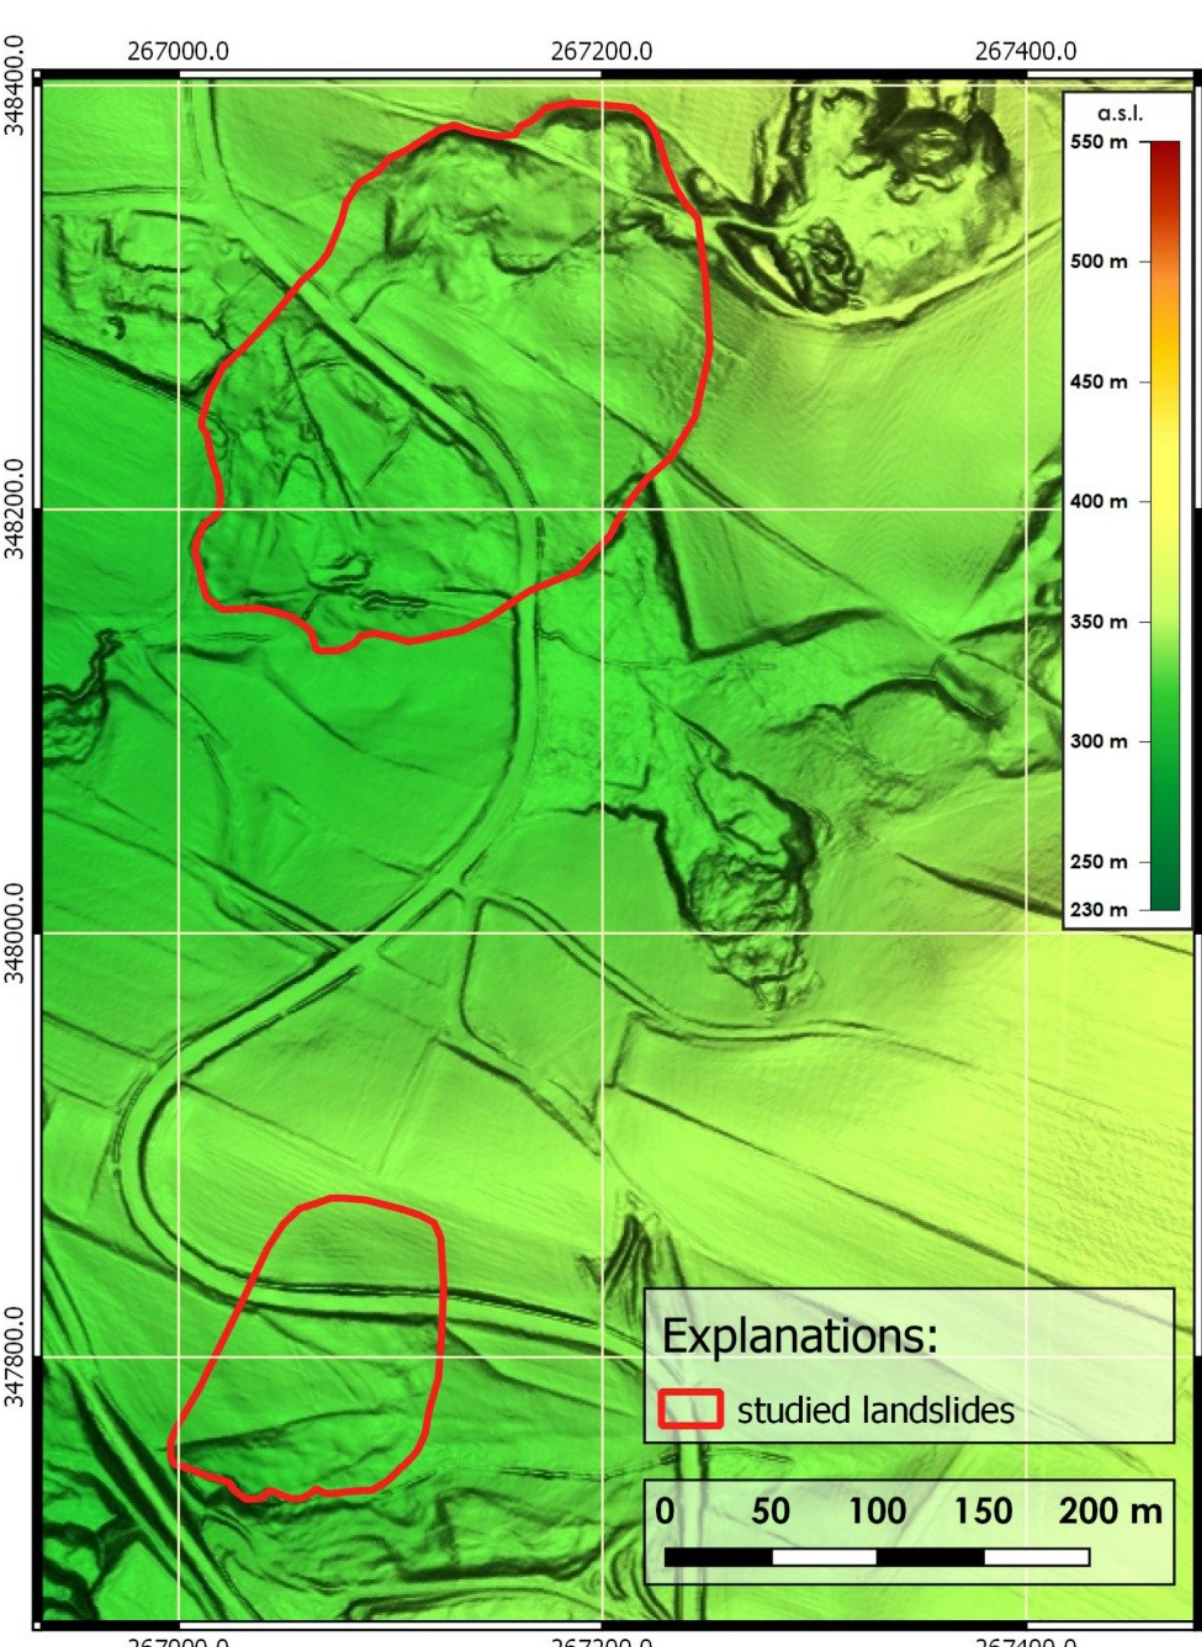
Fig. 2. Field sketch of the measurement area (background from LiDAR data).

The research area is located in the western part the Sudetes - medium attitude mountain range located in Central Europe, SW Poland (Fig. 1). This area is characterized by a hilly landscapes with heights not exceeding 550 m a.s.l. Investigated landslides have developed in the western slopes of Zadnia hill (442 m a.s.l.). This area is characterized by complicated geological structure of the bedrock which is capped by a thin, unconsolidated Quaternary deposits. Metamorphic basement of the study area is represented by low- to high-grade metamorphic rocks belonging to two geological units: Izera Metamorphic Complex (IMC) to the south-west and Kaczawa Metamorphic Complex (KMC) to the north-east. Metamorphic rocks are dissected by Upper Carboniferous rhyolites, lamprophyres and minor quartz veins. To the NE the KMC borders the Wleń Graben. These units are separated by the Intra-Sudetic Fault, which is probably located in investigated landslides. Quaternary deposits cover the substrate, reaching a thickness of up to 20-30 m. The examined landslides are characterized by poorly diversified relief (Fig. 2).

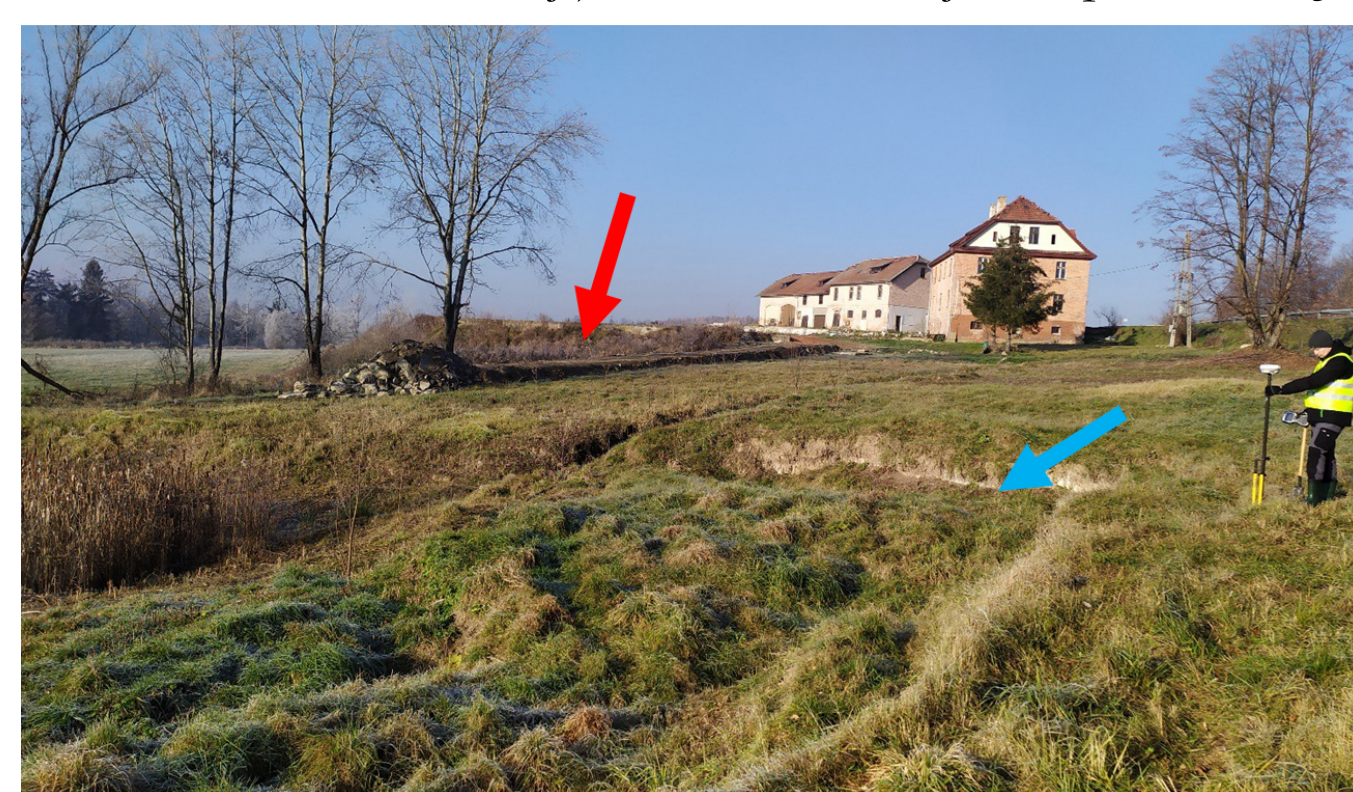
Fig. 4. View of the minor scarp in the northern part of the water reservoir (blue arrow) and the newly created road embankment (red arrow).

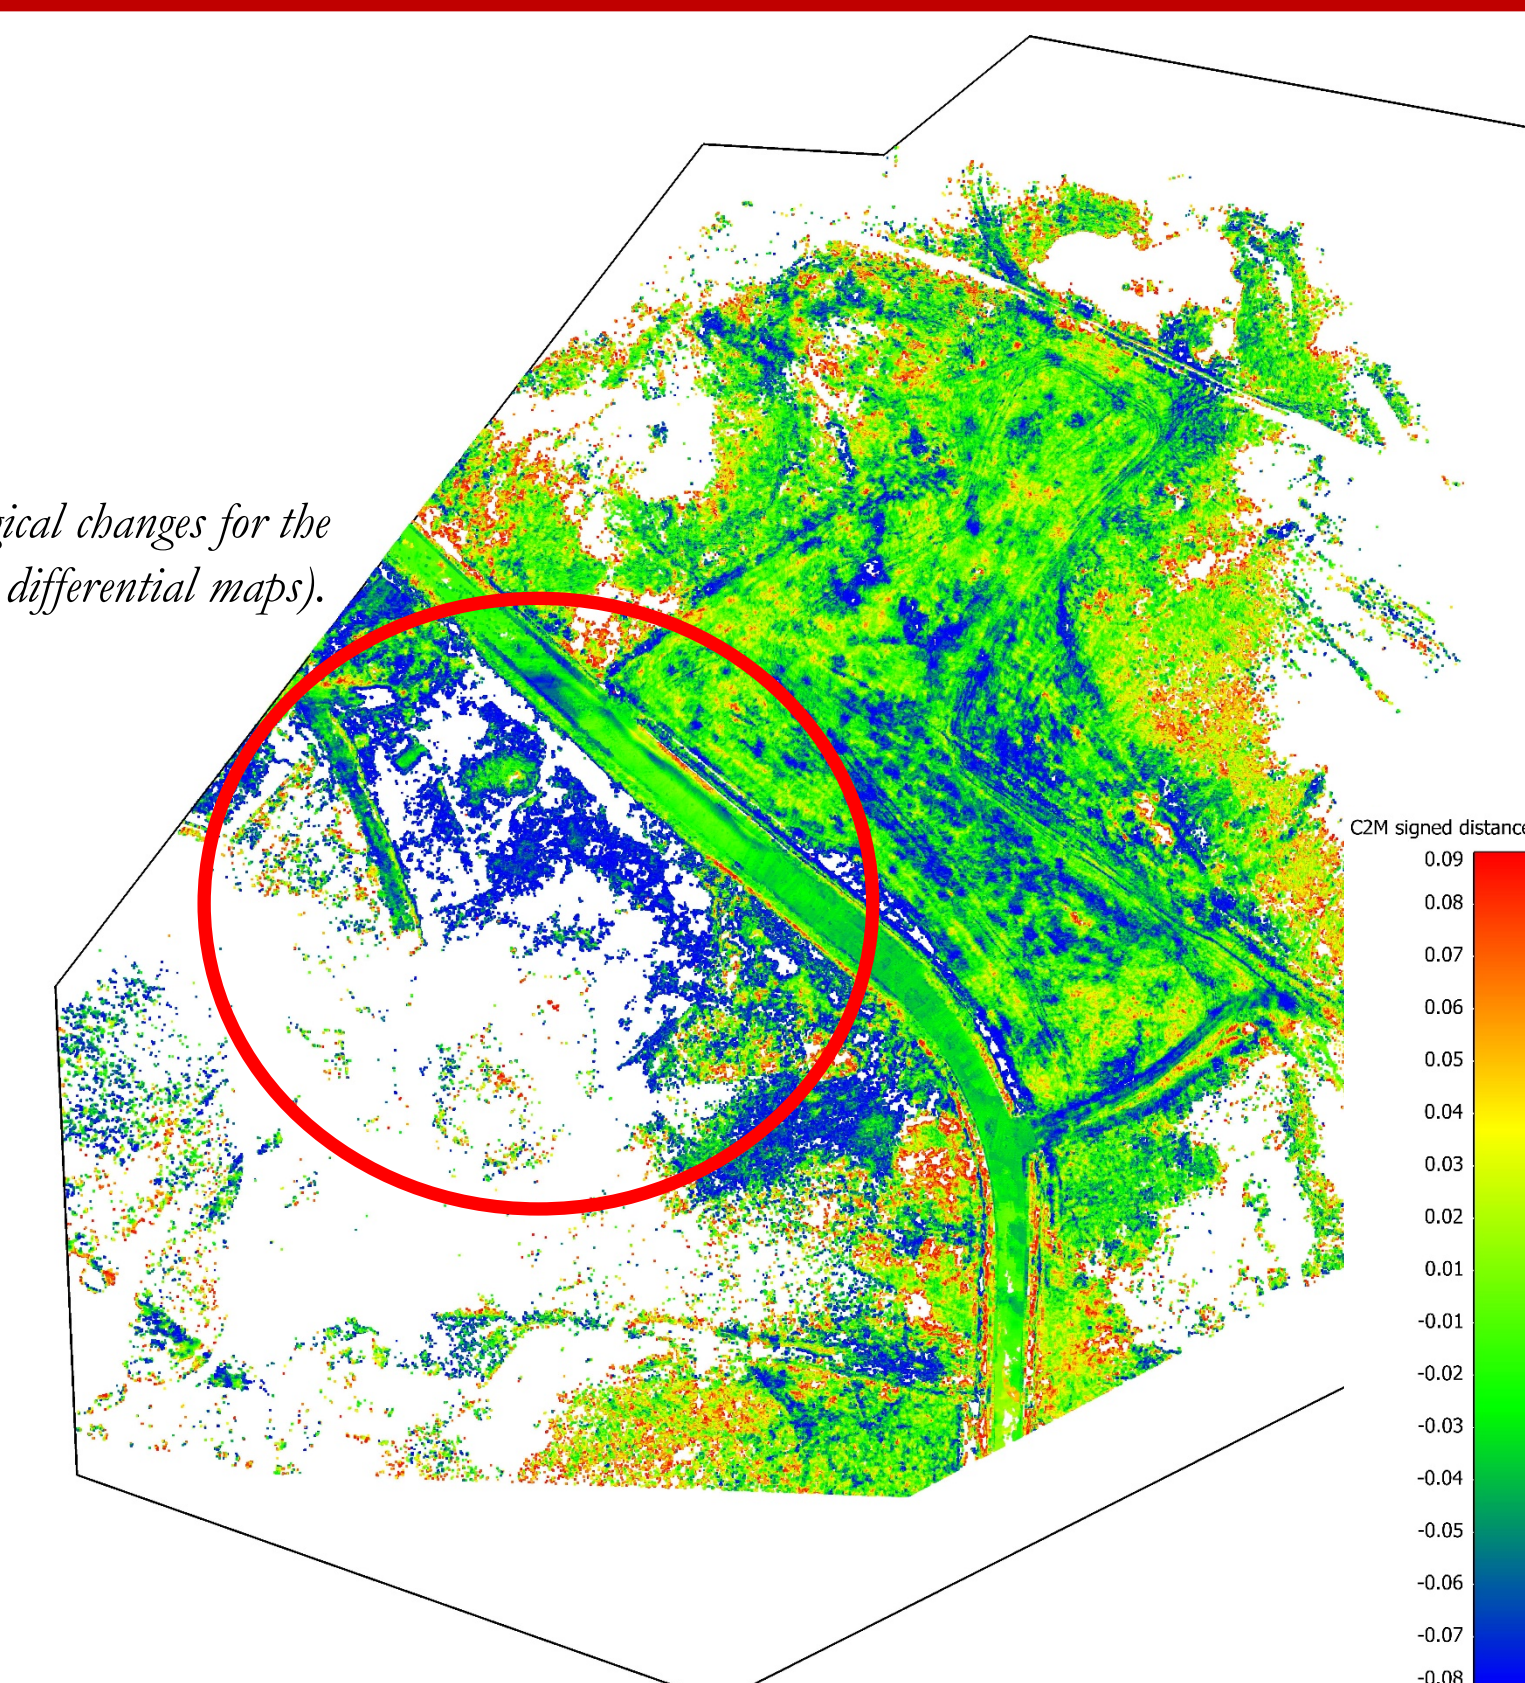
Fig. 5. The extent of the zone of the largest recorded morphological changes for the area of the SIEDLEĆIN 1 landslide (based on the calculated differential maps).

The series of measurement campaigns carried out in 2018-2020 together with a set of developed measurements of the control and measurement network and surface measurements confirmed the presence of a trend of morphological changes in the area of the SIEDLEĆIN 1 landslide from the road to the artificial water reservoir. The morphological changes are clearly visible in the projection of the numerical terrain model. The values of the changes reach the level of individual centimeters. The annual compilation of the developed measurement data and the conducted analyzes did not show any statistically significant changes in the area of the SIEDLEĆIN 2 landslide. Based on the obtained results, monitoring of the area of both landslides was recommended to local government units. This applies in particular to the area within the SIEDLEĆIN 1 landslide marked in Fig. 5, for which morphological changes of several centimeters were recorded. Another danger for this area may be the artificial embankment of the access road weighing down the main body (displaced material) of the landslide. A similar recommendation also applies to the area of the SIEDLEĆIN 2 landslide. Despite the fact that the values of the differential analysis results obtained so far have balanced on the edge of the measurement error, attention should be paid to the fact of active agricultural activity in this area, which may be one of the dangerous factors influencing the start of mass movements.
